### Vu Villa Staircase Structural Repair

## Vu Villa Staircase Structural Repair

The Vu Villa in uptown Butte has a staircase leading to the second floor that are beginning to sag and need structural support to fix the sag in the stairs.

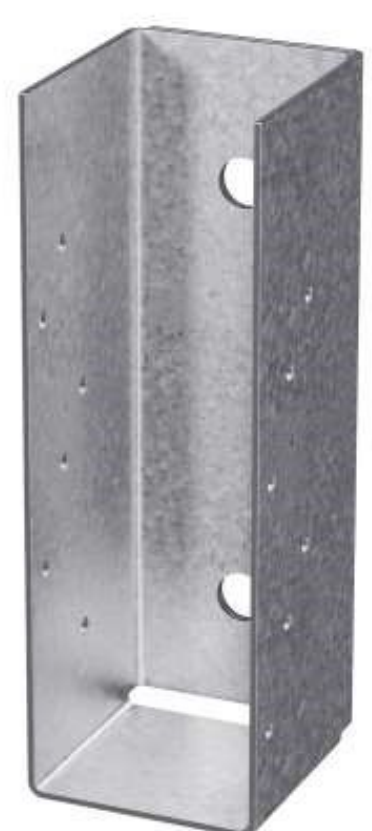
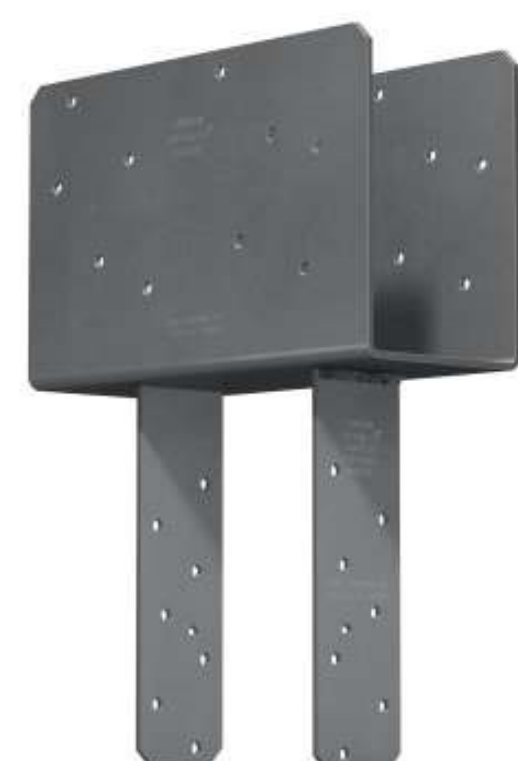
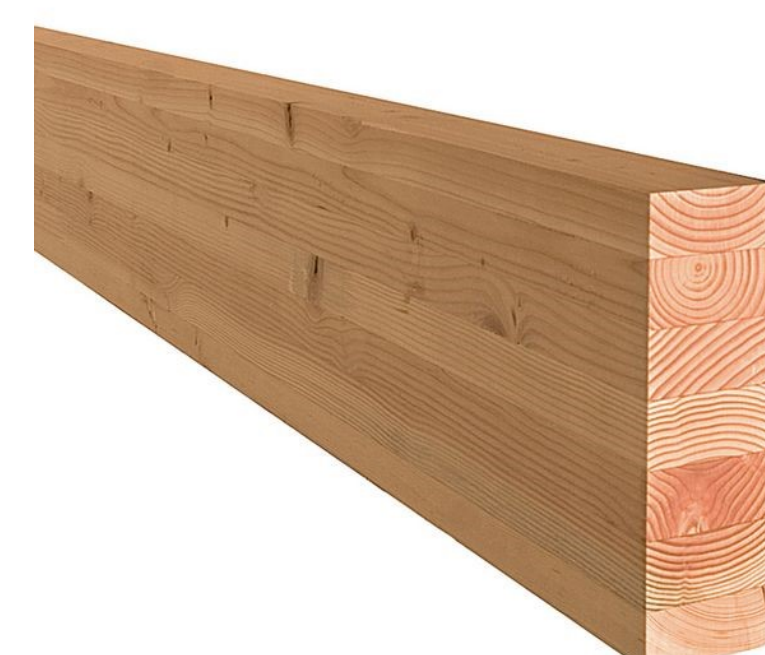
Using the LRFD method of wood design, the loading conditions were determined. Using the ultimate load, the beam size was determined, being a **3 1/2" x 11 7/8" 24F-V4 DF/ DF Glulam Beam**. The connections needed were designed using Simpson Strong-Tie connections. The connections being used are **MBHU 3.56/11.88KT** and **CCQ74SDS2.5**.

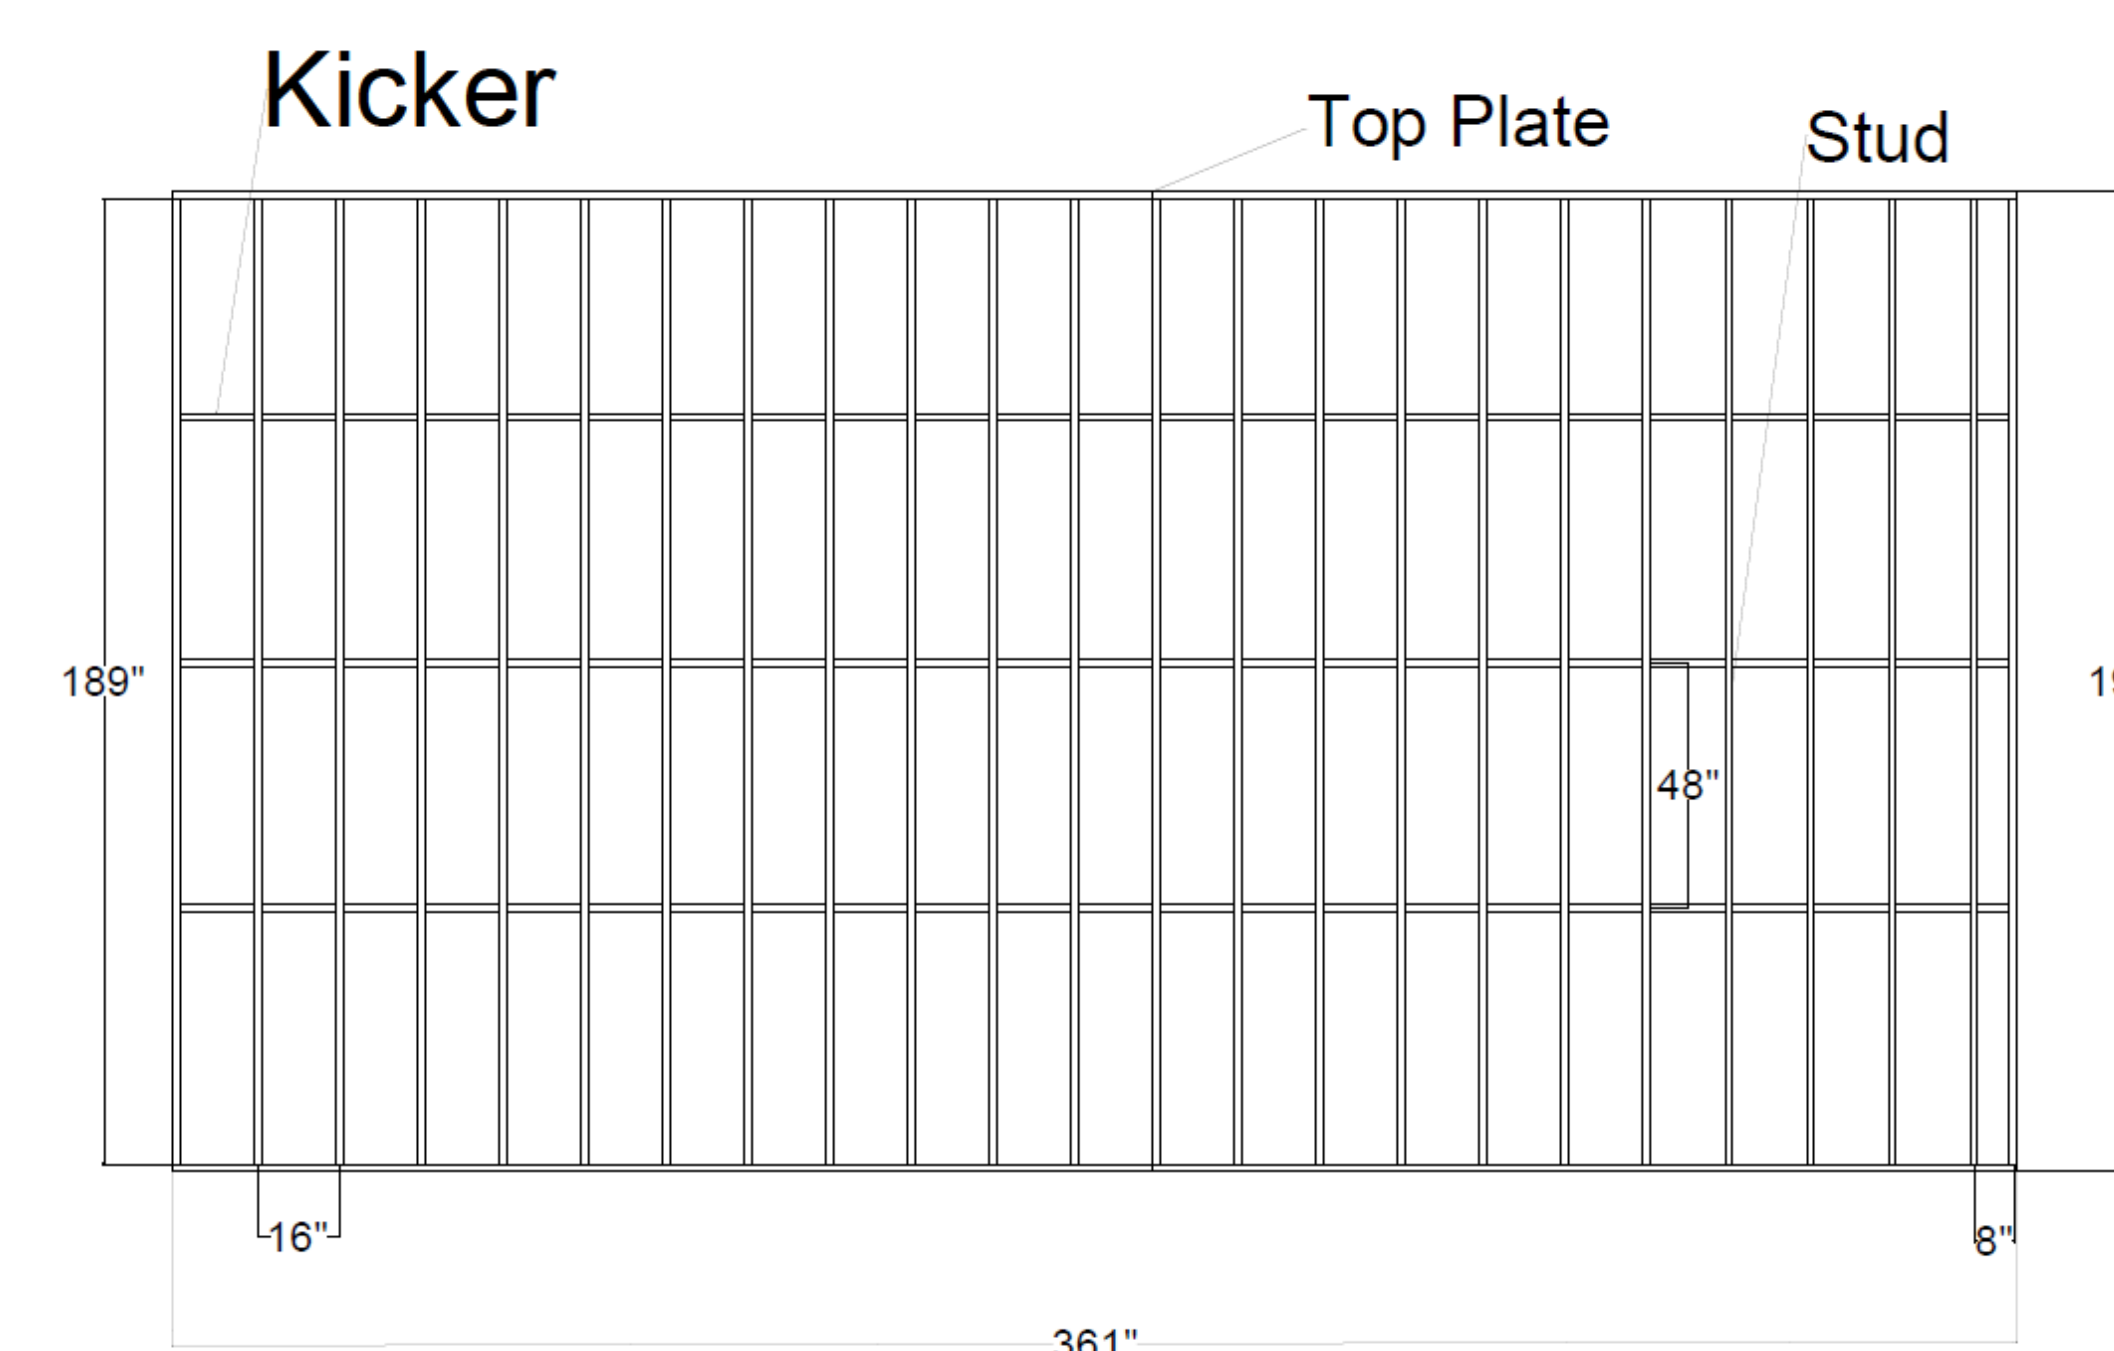
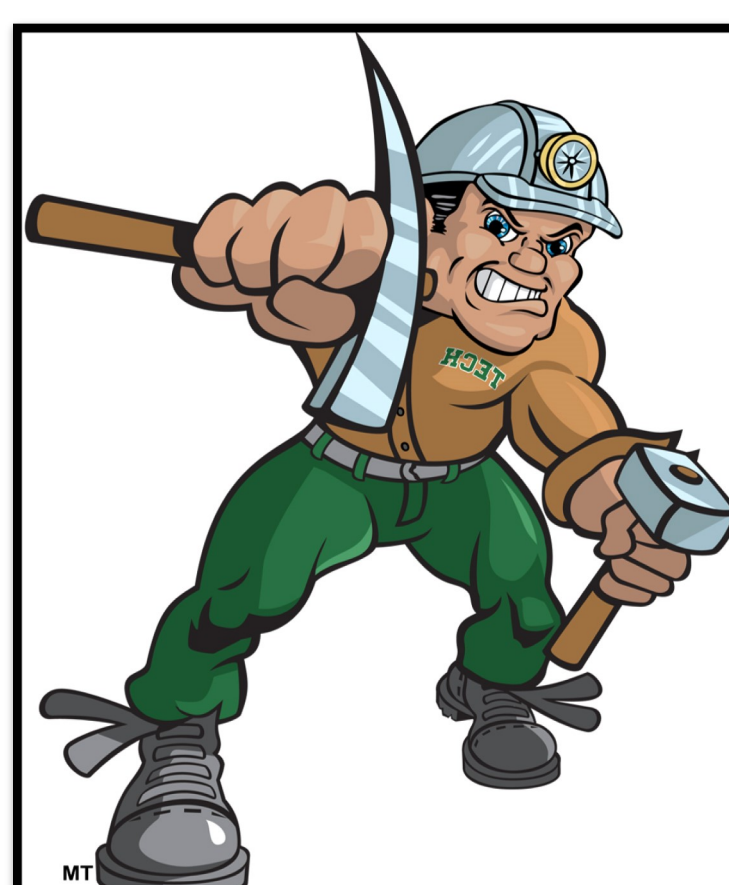
- . 2x6 Hem-Fir Used for Studs, Top Plate, Kickers, and Bottom Plate
- . 16 " O.C. stud spacing
- . 16' Height, 32'1" Length
- . Use 10d nails
- . All connection will be toe-nailed
- . Wall connects to Staircase Stringer
